# preserving the past

## to learn the lessons that teach for tomorrow

### THE RESTORATION OF THE MONTAUK POINT LIGHTHOUSE

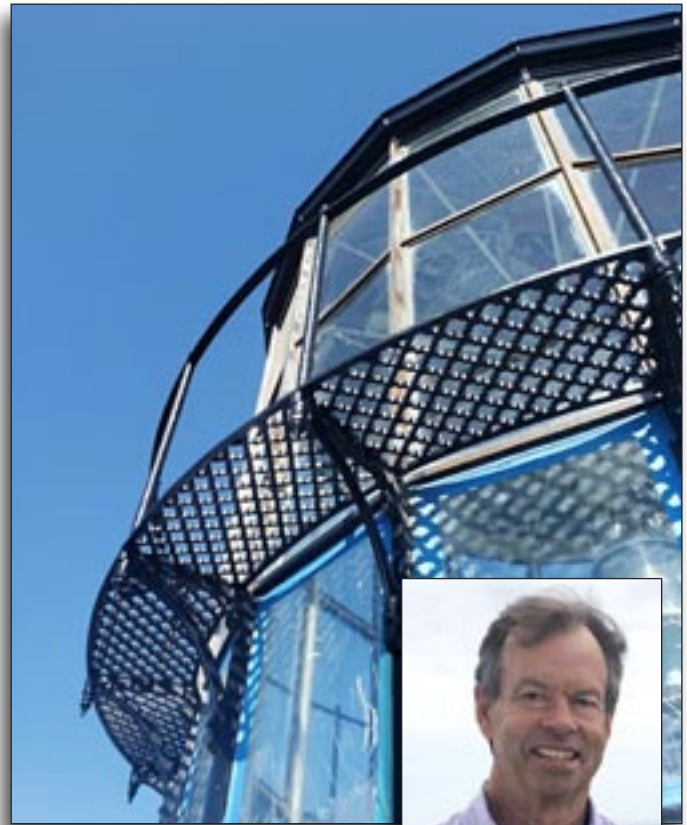
*The lantern, catwalk and brick addition are now properly restored. At right is George Abbale of A.R.I. who specializes as a historic site restoration consultant. His meticulous and scientific approach to this project is truly forensic in scope.*

The restoration of the sandstone facade will begin with the removal of existing paint starting with the lightning rod, vent ball, upper and lower catwalks as well as the brick addition. Once these locations are fully prepared and cleaned properly, we then recoated the metals and the brick addition with the proper coating materials. This remedial work will help the lighthouse remain structurally sound for another 100+ years.

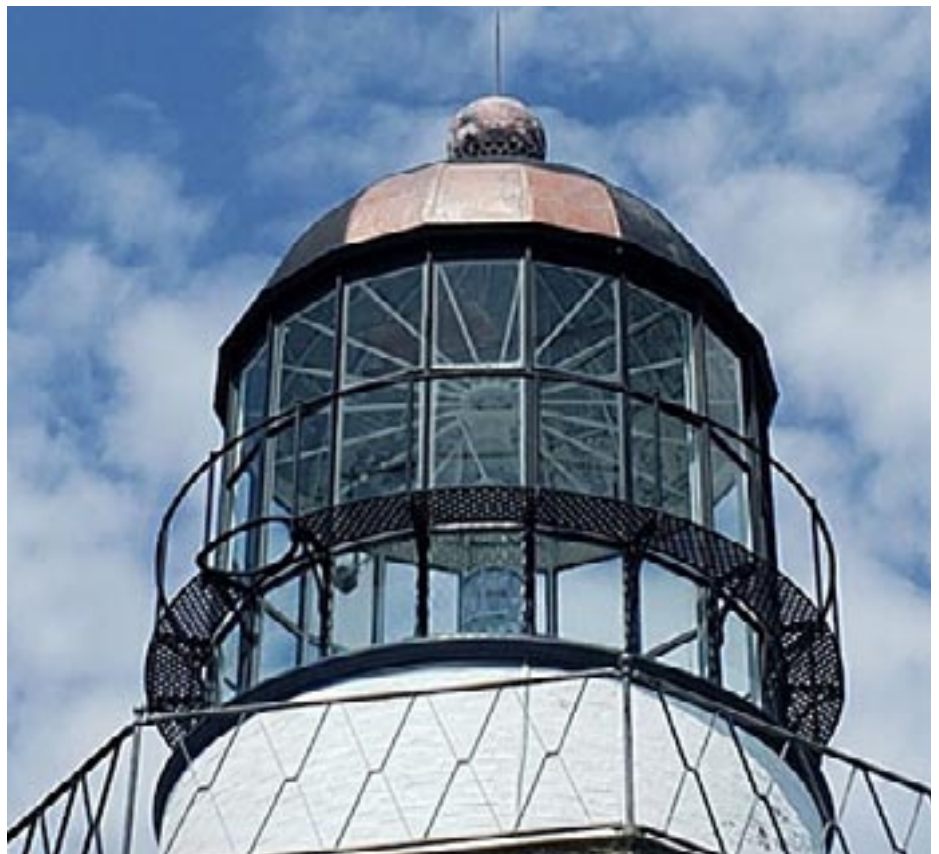
*The year of the alteration of the Lighthouse is incorporated into the iron railing at the watchdeck level.*
